**EXPERIMENTAL CULVERT PIPE, STH 80  
JUNEAU AND WOOD COUNTIES, WISCONSIN**

**FINAL REPORT**

**NOVEMBER 2003**

**FEDERAL EXPERIMENTAL PROJECT # WI 80-02,03,04**

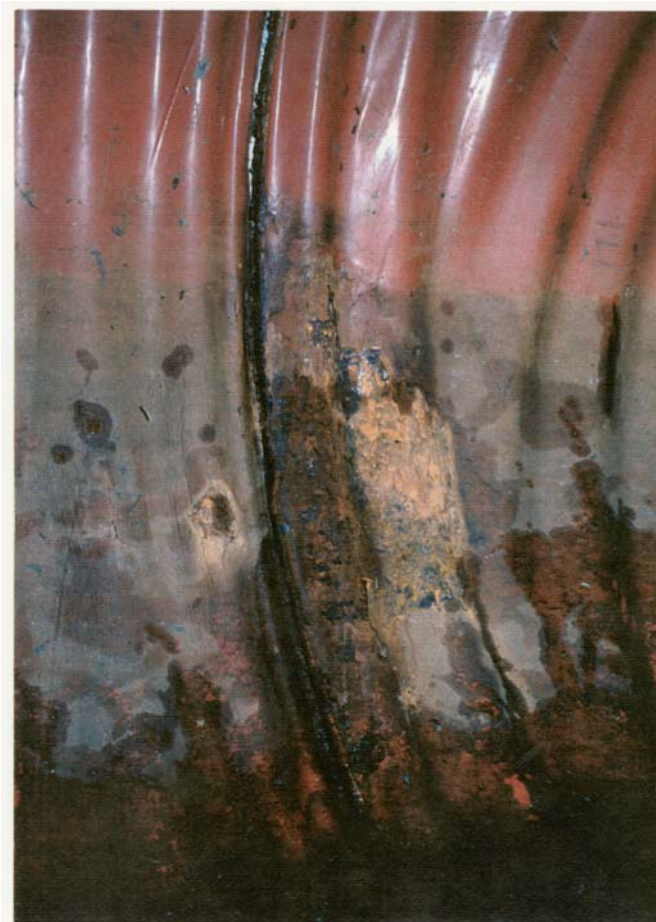
Station 713+36. Loss of epoxy coating at first joint of epoxy bonded pipe and advanced corrosion of steel. This part of pipe commonly under water. Inlet. 1994

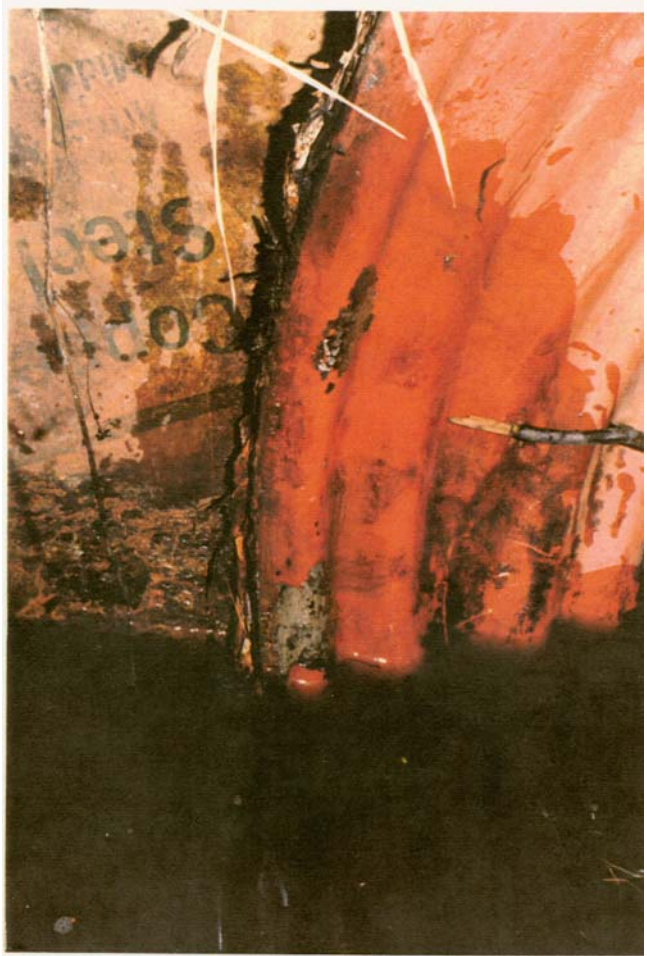
Station 976+40. Epoxy bonded pipe.  
Loss of epoxy at inlet of pipe. Note  
corrosion of apron endwalls, with no  
epoxy coating. 1987

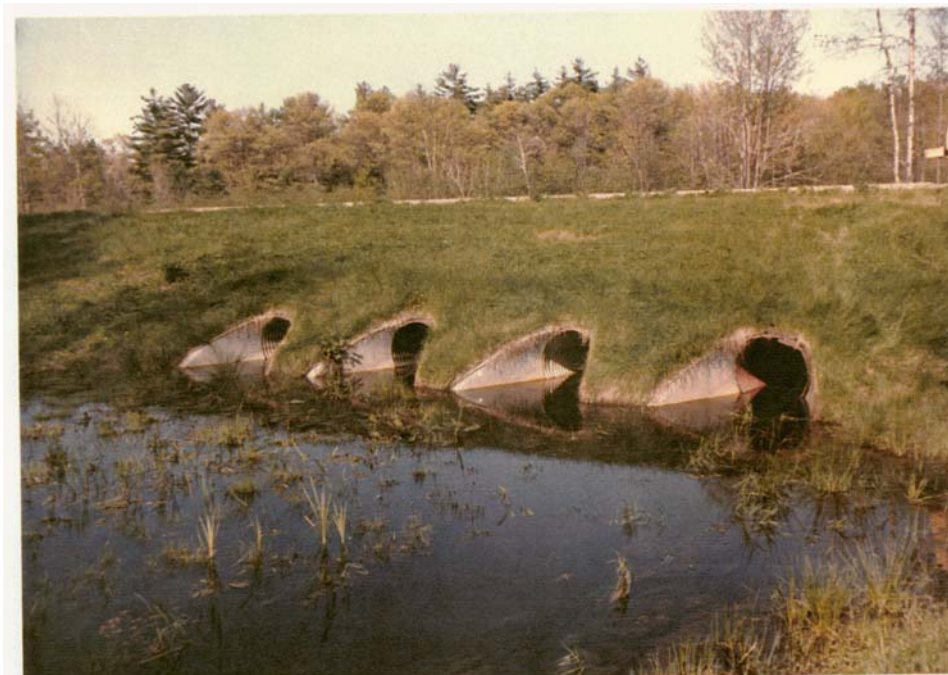
Station 1111+70. West end. From left to right; aluminum, polymeric coated, aluminized steel and epoxy bonded.

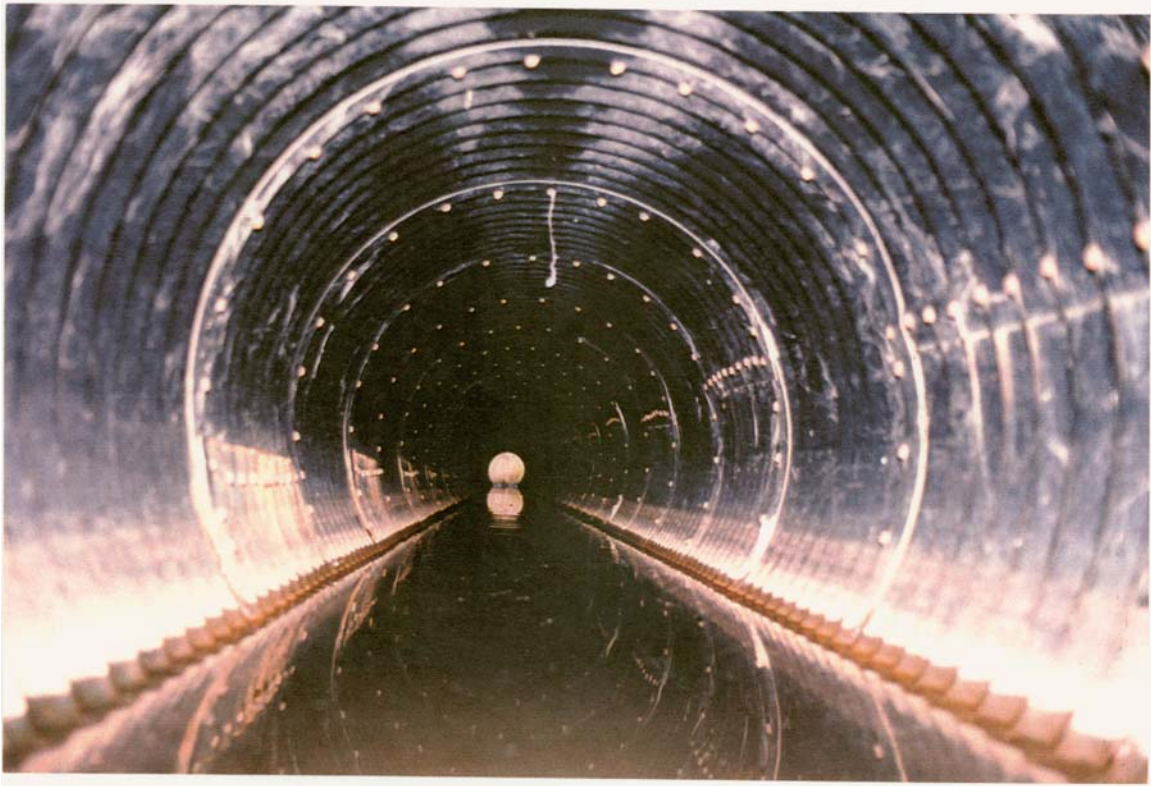
Station 1111+70. Polymeric coated pipe. West end. 1994

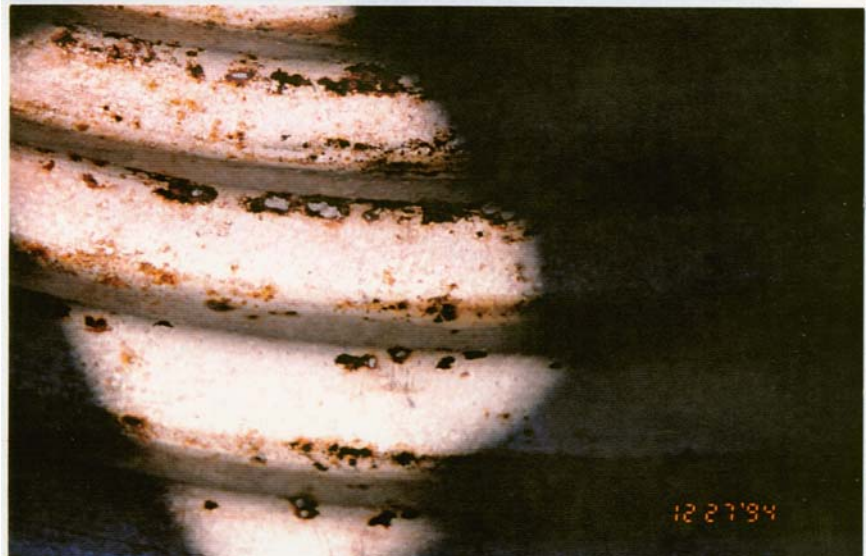
Station 1111+70. Loss of barrier coating along edge of organic accumulation and development of pits on tops of corrugations beneath organic material in invert of aluminized steel pipe. 1994

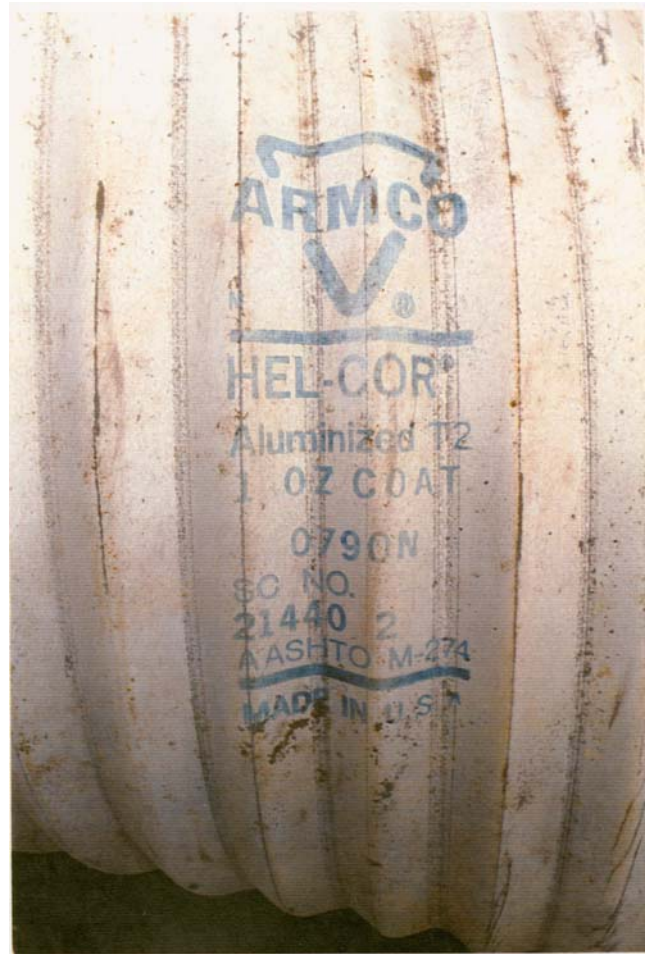
Station 1111+70. Specifications,  
aluminized steel and polymeric  
coated steel pipe.
